Status of SPADIC development Part I

Michael Krieger Lehrstuhl für Schaltungstechnik und Simulation ZITI, Uni Heidelberg

CBM Collaboration Meeting, GSI, 11.04.2016

Status of SPADIC development Part II: Analysis of 'hang up' Problem in SPADIC 1.0

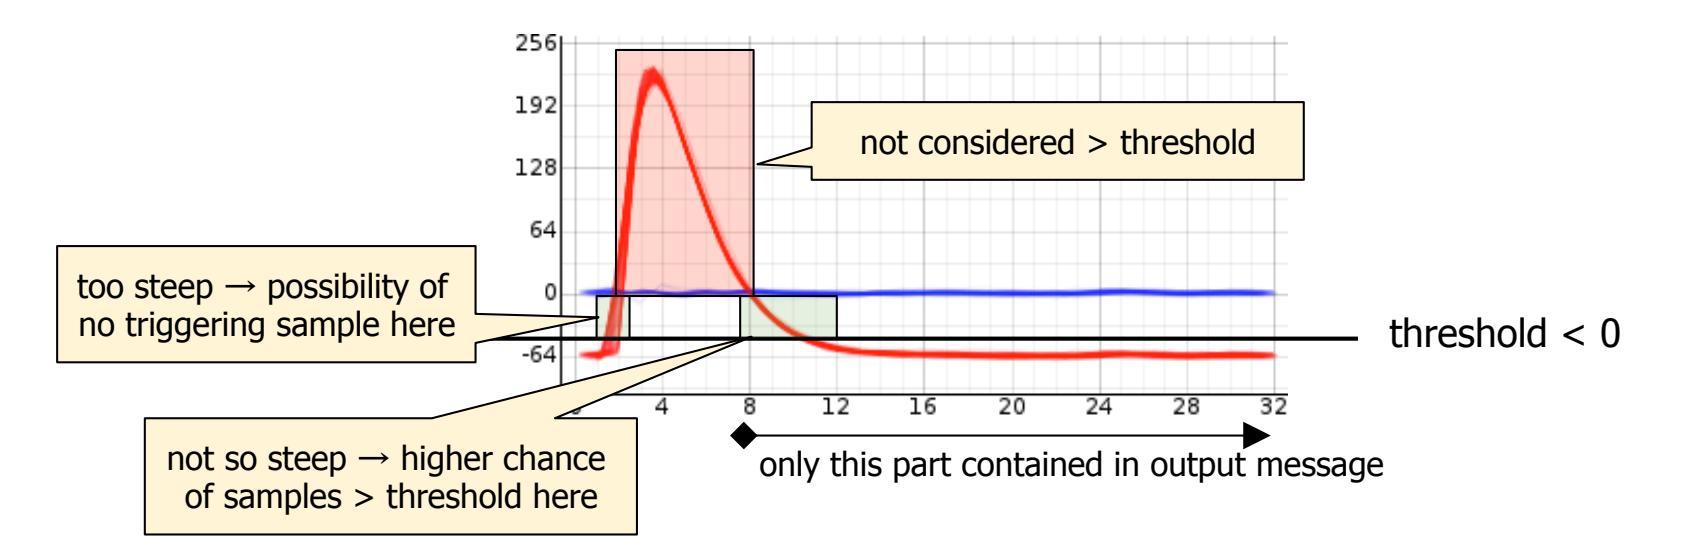
Fix of the comparator bug

- Positive signals do not compare "greater than" negative thresholds in SPADIC 1.0
- Was e.g. responsible for behaviour like triggering on the tail of a pulse instead of its rising edge:

I'm quite sure I fixed it, but cannot prove it yet (because of the 28 register writing limit)

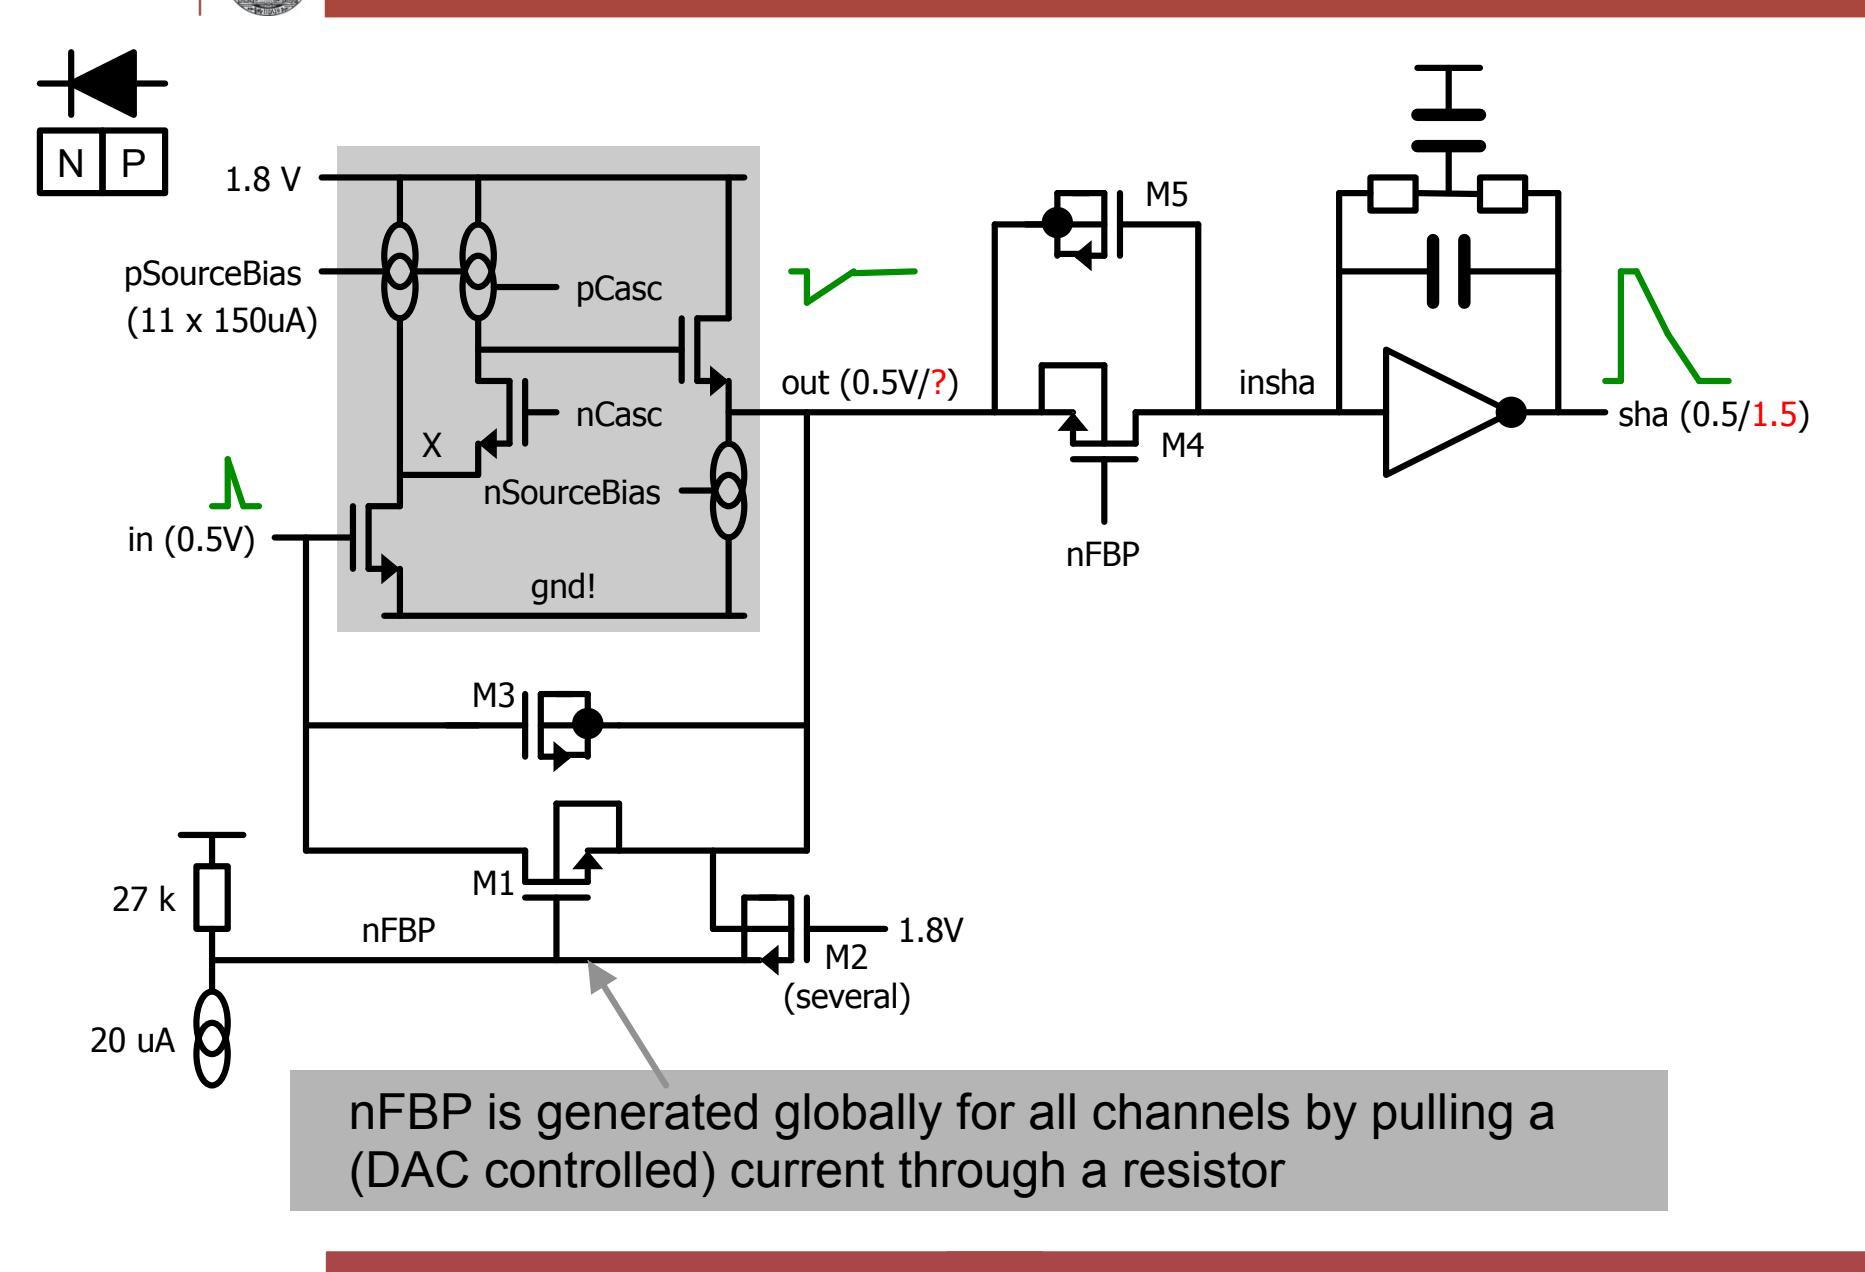
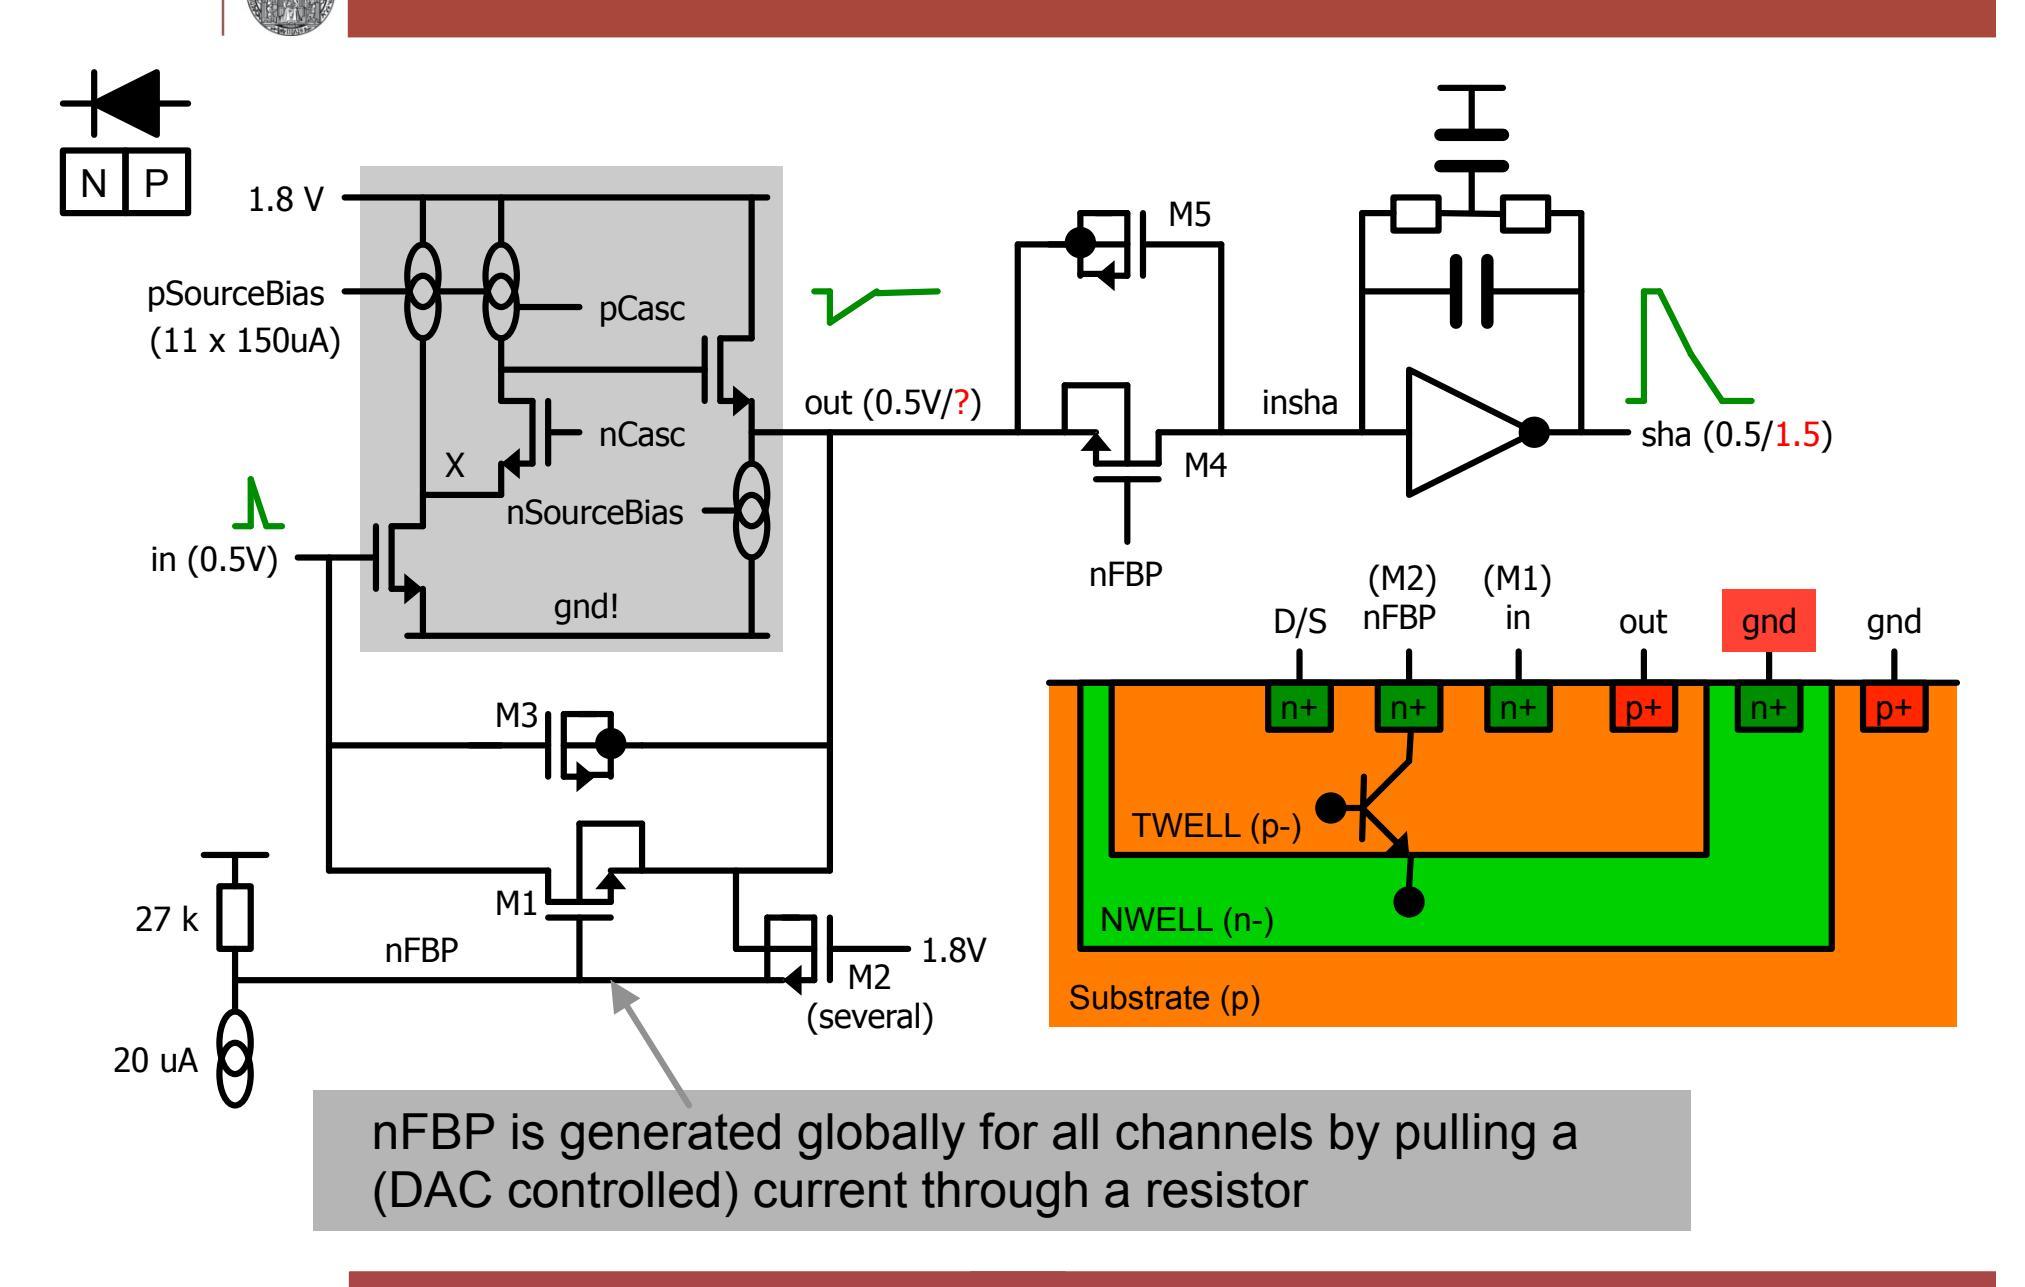
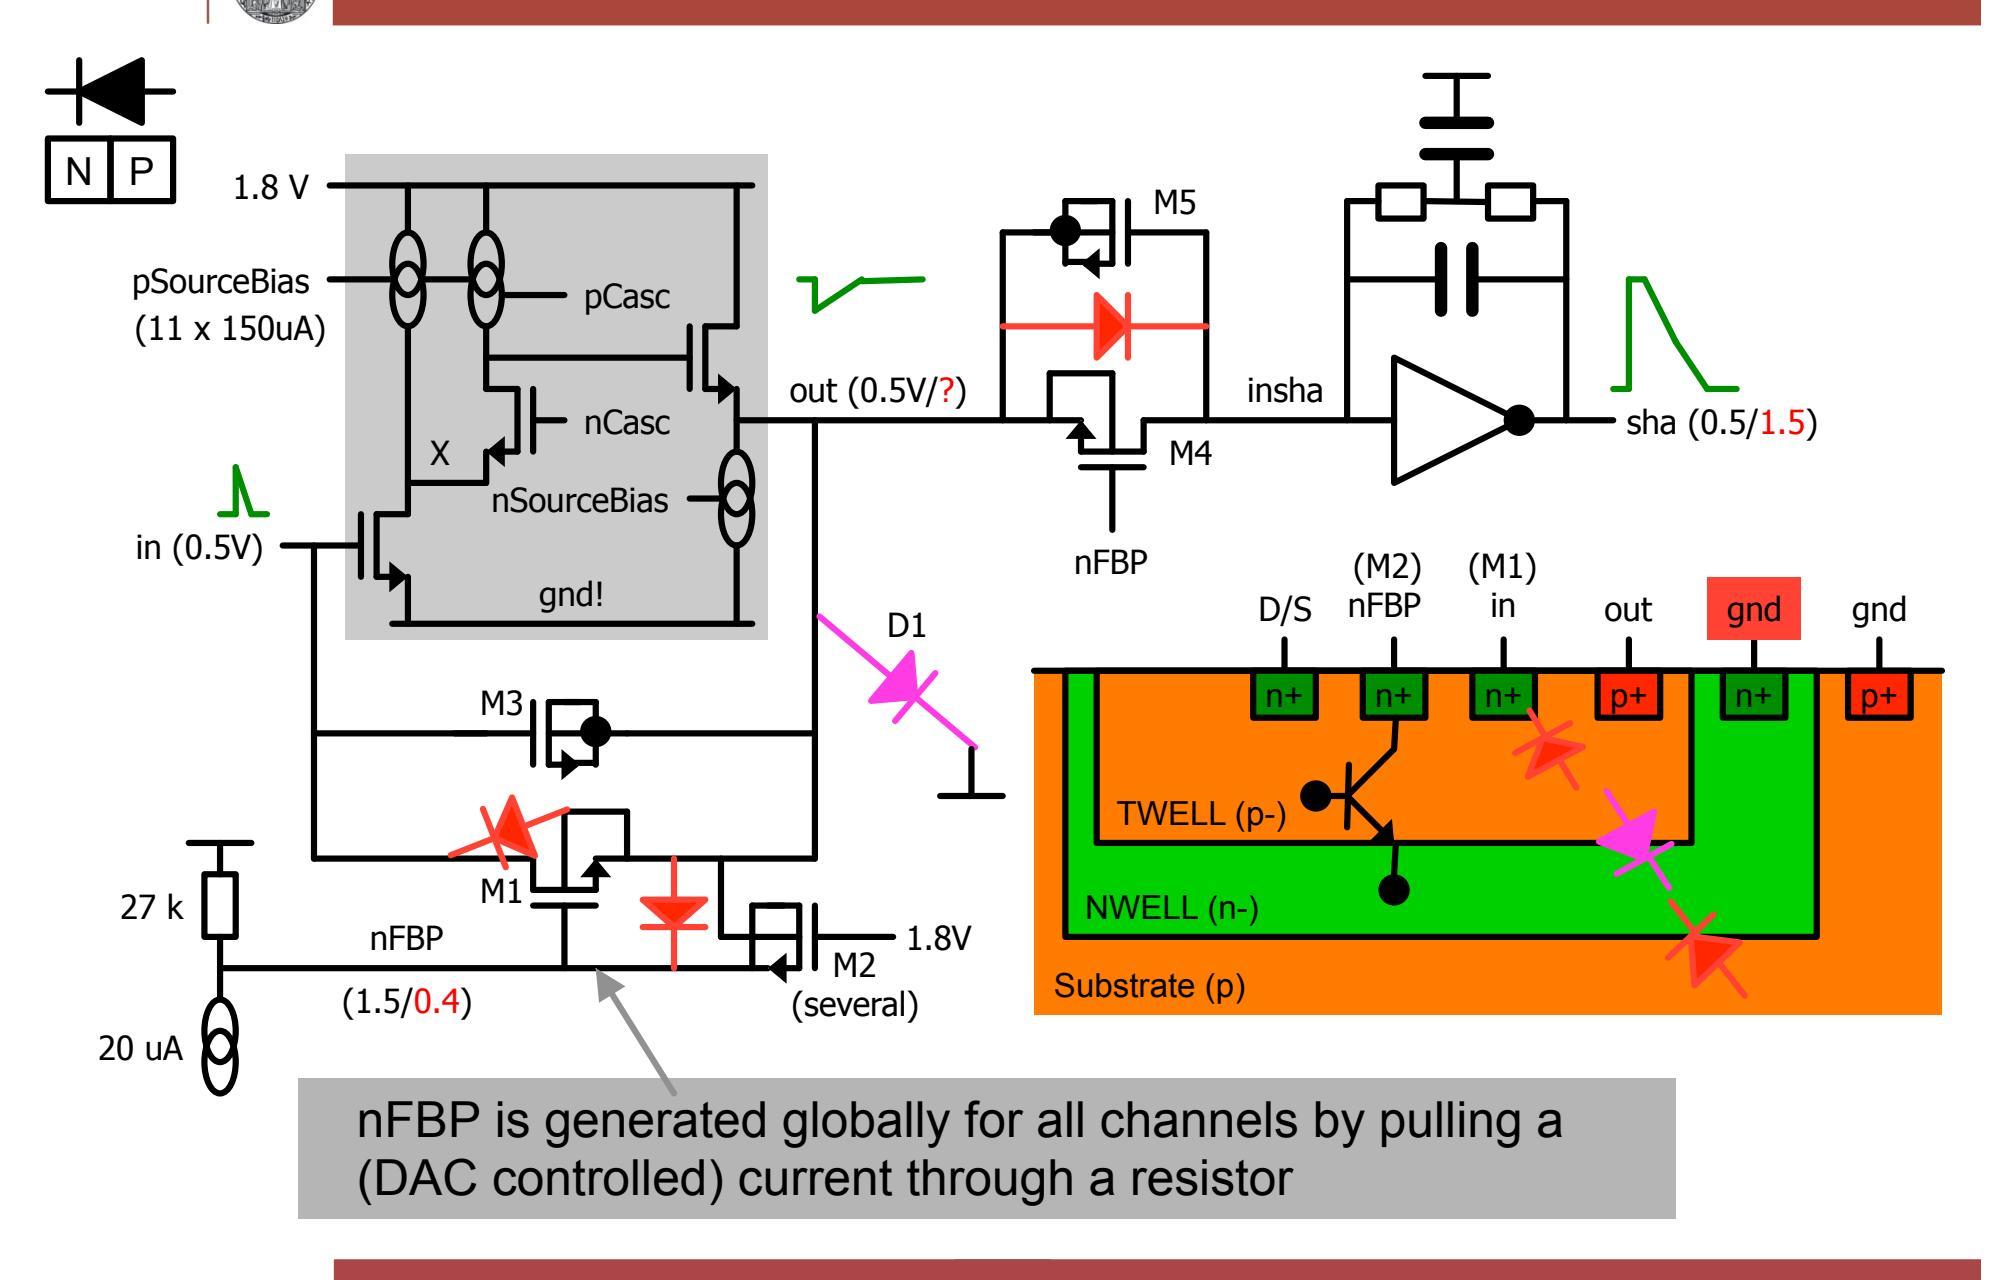
Diagram of Relevant Circuit Elements

In Spadic1.0, the analogue channels sometimes go to a 'hang up' mode (named 'BAD' here) from which they are hard to recover.

- 1. BAD occurs only in the frontend for *positive* input pulses
- 2. BAD is triggered by high DAC settings of nFBP (low nFBP) or pSourceBias
- 3. When BAD, shaper output shows high positive voltage (i.e. a 'high' signal)
- 4. When BAD, control voltage nFBP drops from nominal ~1.5V to ~0.4V
- 5. When BAD, supply current for *one* channel increases from 2-3mA to 10mA
- 6. Triggering of BAD does not depend on nSourceBias
- 7. BAD is stopped when pSourceBias is turned off
- 8. BAD occurs sooner, if more channels are enabled
- 9. There is hysteresis, i.e. it requires very low settings to stop BAD
- 10. Input characteristic of one channel (see later) is different if other channels are enabled.

- The NMOS devices used in the feedback M1-M5 are triple well devices BPW with a cross section as shown.
- Design bug: NWELL is connected to gnd! (instead of vdd!)
- The error state is reached when the SF pulls net out high
 - This leads to a high current in the TWELL-NMOS diode D1
 - The high potential at the TWELL opens up the vertical (parasitic) npn-s which pull all n+ implants of the BPWs towards ground: The base-emitter current is very high (10mA) so that even a very low β provides significant collector current in the n+ implants
 - Node nFBP which goes low via M2, so that the feedback in the amplifier is lost.
 - The input is also pulled low (via M1) as well so that the output (SF) goes high. This locks the state.
 - Net insha is also pulled low so that output goes high

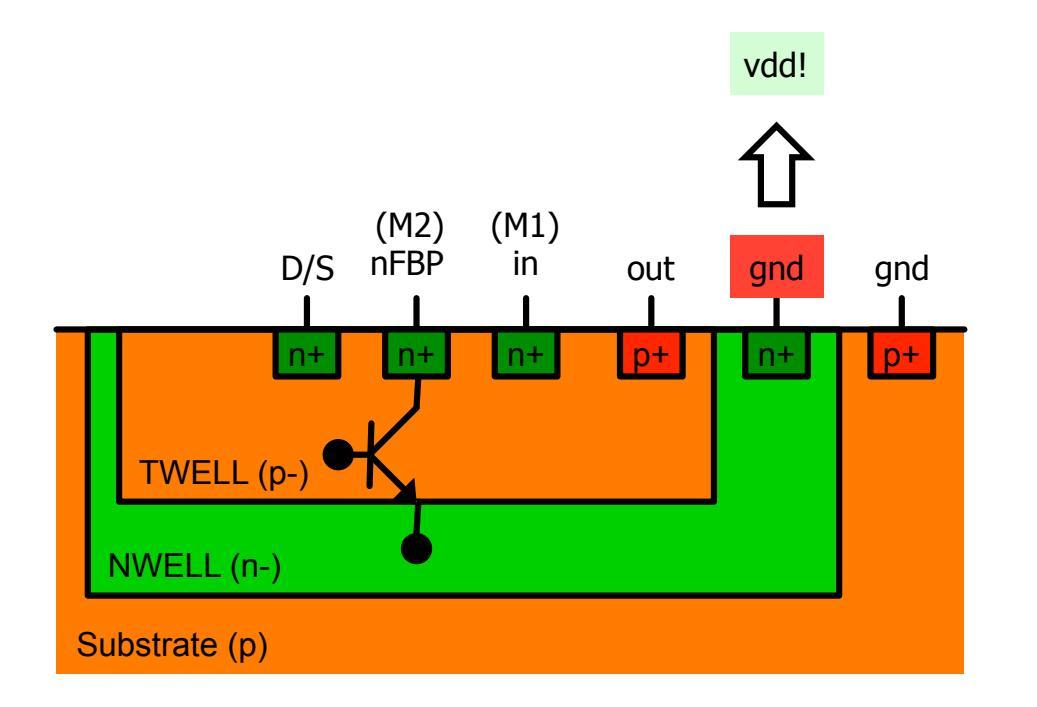
- The error is NOT seen in simulation because the N_BPW devices have NO NWELL terminal in the schematics!
- In the layout, the NWELL can be connected ANYWHERE! Everything is correct as there is no guideline from the schematic!
- This is a serious risk occurring because the UMC design kit implements the '5-terminal' BPWs as 4 terminal MOS!

Issue was fixed in SPADIC1.1 by connecting the NWELL correctly to vdd!

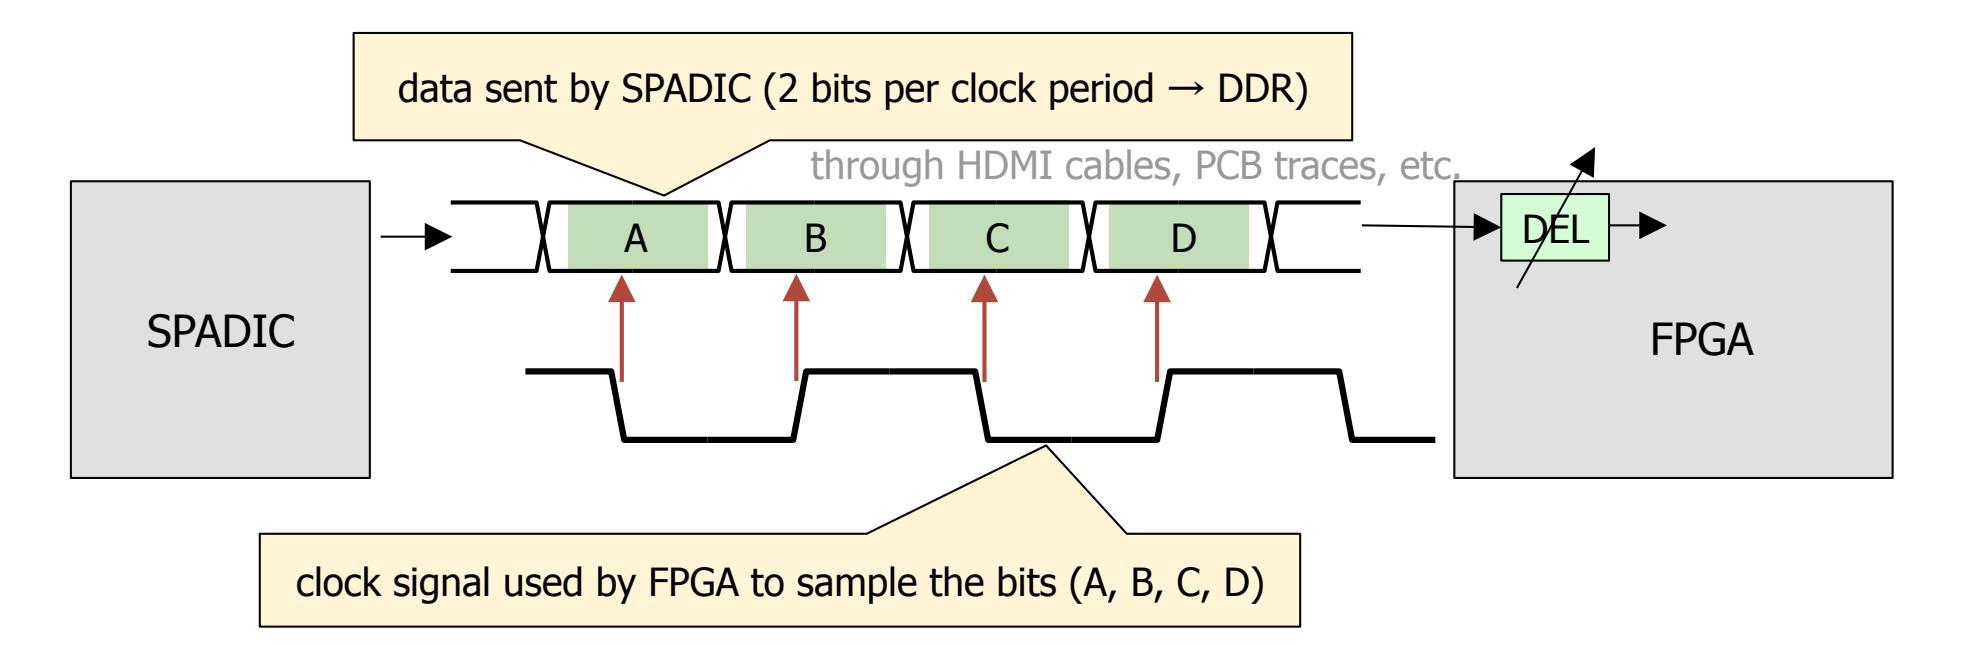
The Glitch explained (1)

- clock edge must occur inside green area (while the signal is stable)
- to ensure this, the FPGA can shift the input signal

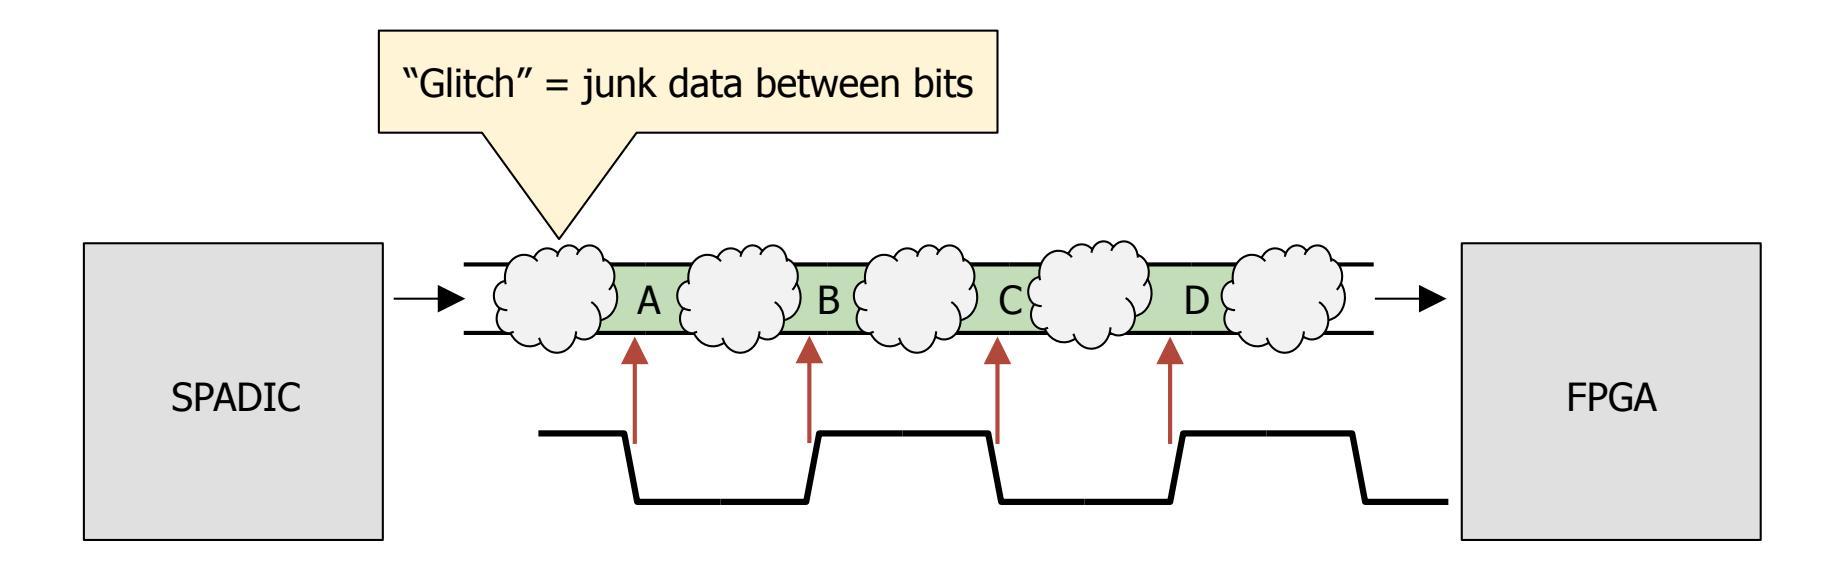
The Glitch explained (2)

- clock edge must occur inside green area (while the signal is stable)
- to ensure this, the FPGA can shift the input signal
- with the Glitch, the FPGA needs to aim more precisely
